Lake Name: Hosakerehalli Kere

Date of Visit: 22.01.2016

EMPRI Cartography for Hosakerehalli Kere

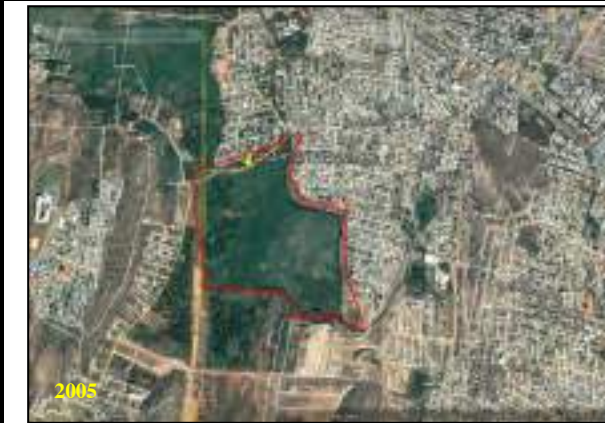
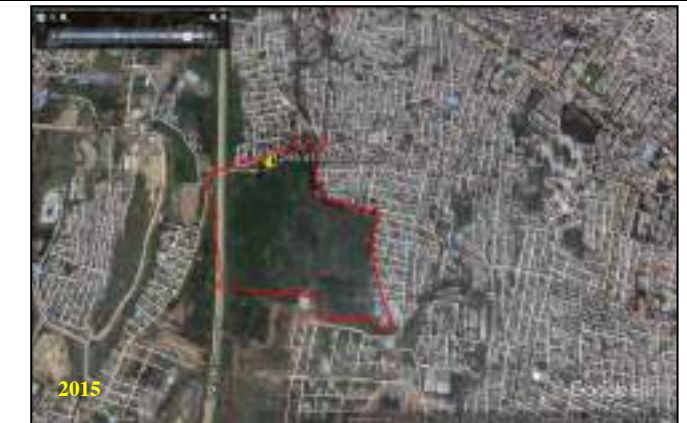
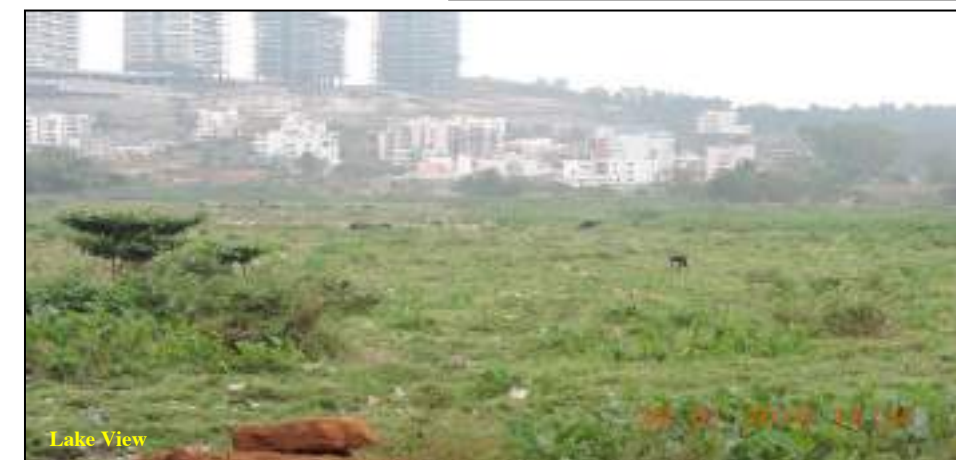
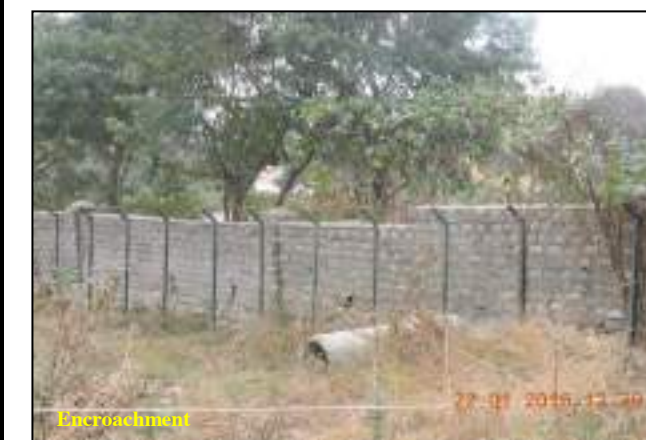
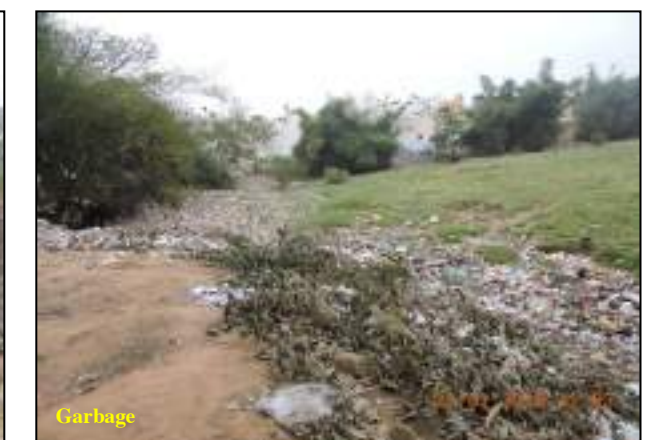
THREATS	
Direct Point Source Pollutants	: Dumping of Garbage wastes Construction Debris
Indirect Point Source Pollutants	: Sewage
Quantity of Sewage Inflow (Cumecs)	: No flow through Storm water drain
Encroachment	: Road, Factory & Houses (3%)
Soil Excavation	: Nil
Weeds	: Complete

Conservation Strategies		
S. No.	Issues	Strategies
1	Encroachment	Survey by the consent Authority & evict the encroachment
2	Dumping of wastes	Fence the lake and create awareness
