Lake Name: Kambhipura Govt. Karabu Kere-2

Date of Visit: 11.02.2016

EMPRI Cartography for Kambhipura Govt. Karabu Kere-2

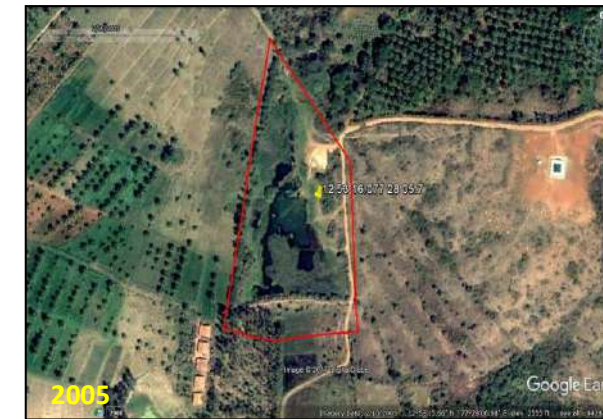
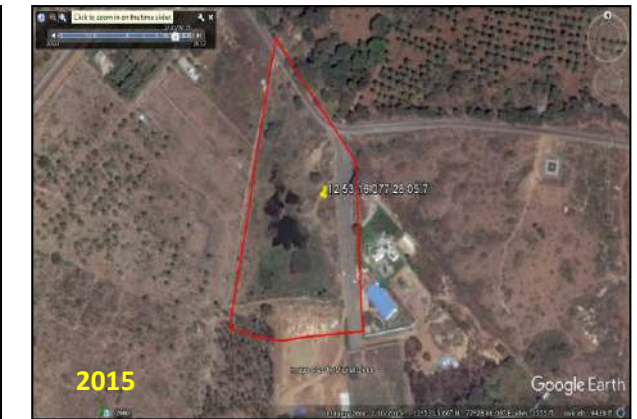
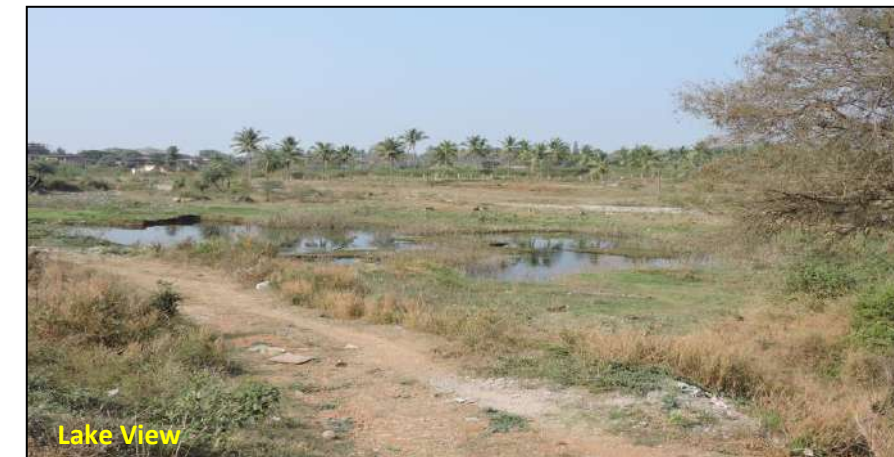
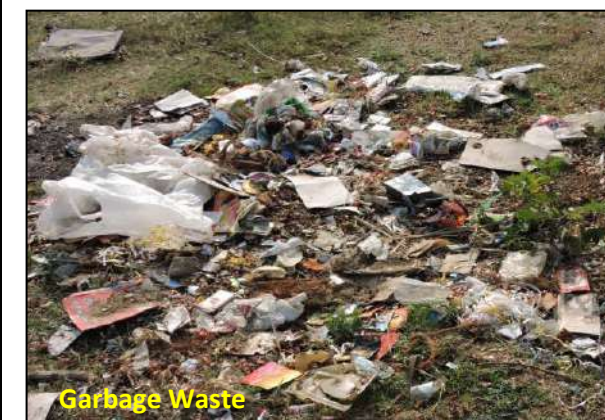
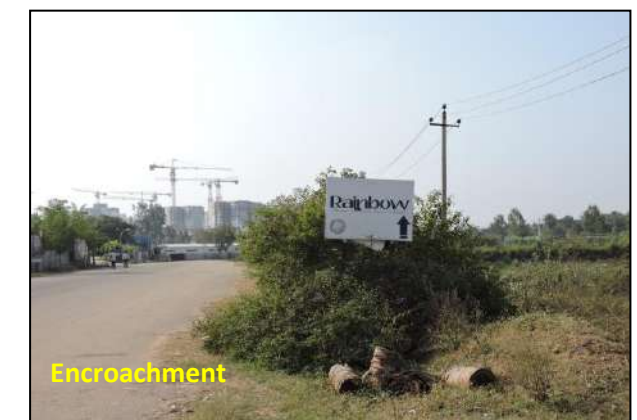
Road : 2	TKN (mg/l)	Dry		
Surrounding Area: Plantation, Vacant land & Apartment	Phosphate (mg/l)	Dry		Date of Visit : 16.02.17
	Total Coliform (MPN/100ml)	Dry		
BIOTIC DATA		SOCIO-ECONOMIC VALUE		
Vegetation Cover : Partial		Drinking Water : Not Observed		
Vegetation Type : Growing on bank		Washing : Not Observed		
Aquatic Flora : Emergent		Bathing : Not Observed		
Fauna : Birds, Butterfly & Dragonfly		Livestock Management : Not Observed		
		Irrigation : Not Observed		
		Fishing : Not Observed		
Amphibian : Not Observed		Cultural Activities : Not Observed		
Reptile : Not Observed		Recreational Activity : Not Observed		
Mammals : Not Observed		Others Uses : Not Observed		
THREATS				
Direct Point Source Pollutants	: Dumping for Garbage, Construction Debris & Poultry Waste			
Indirect Point Source Pollutants	: Nil			
Quantity of Sewage Inflow (Cumecs)	: No			
Encroachment	: Road (2%)			
Soil Excavation	: No

Weeds	: Partial

Conservation Strategies		
S. No.	Issues	Strategies
1	Waste dumping	Fence the lake and create awareness
2	Encroachment	Survey by consent Authority & evict the encroachment

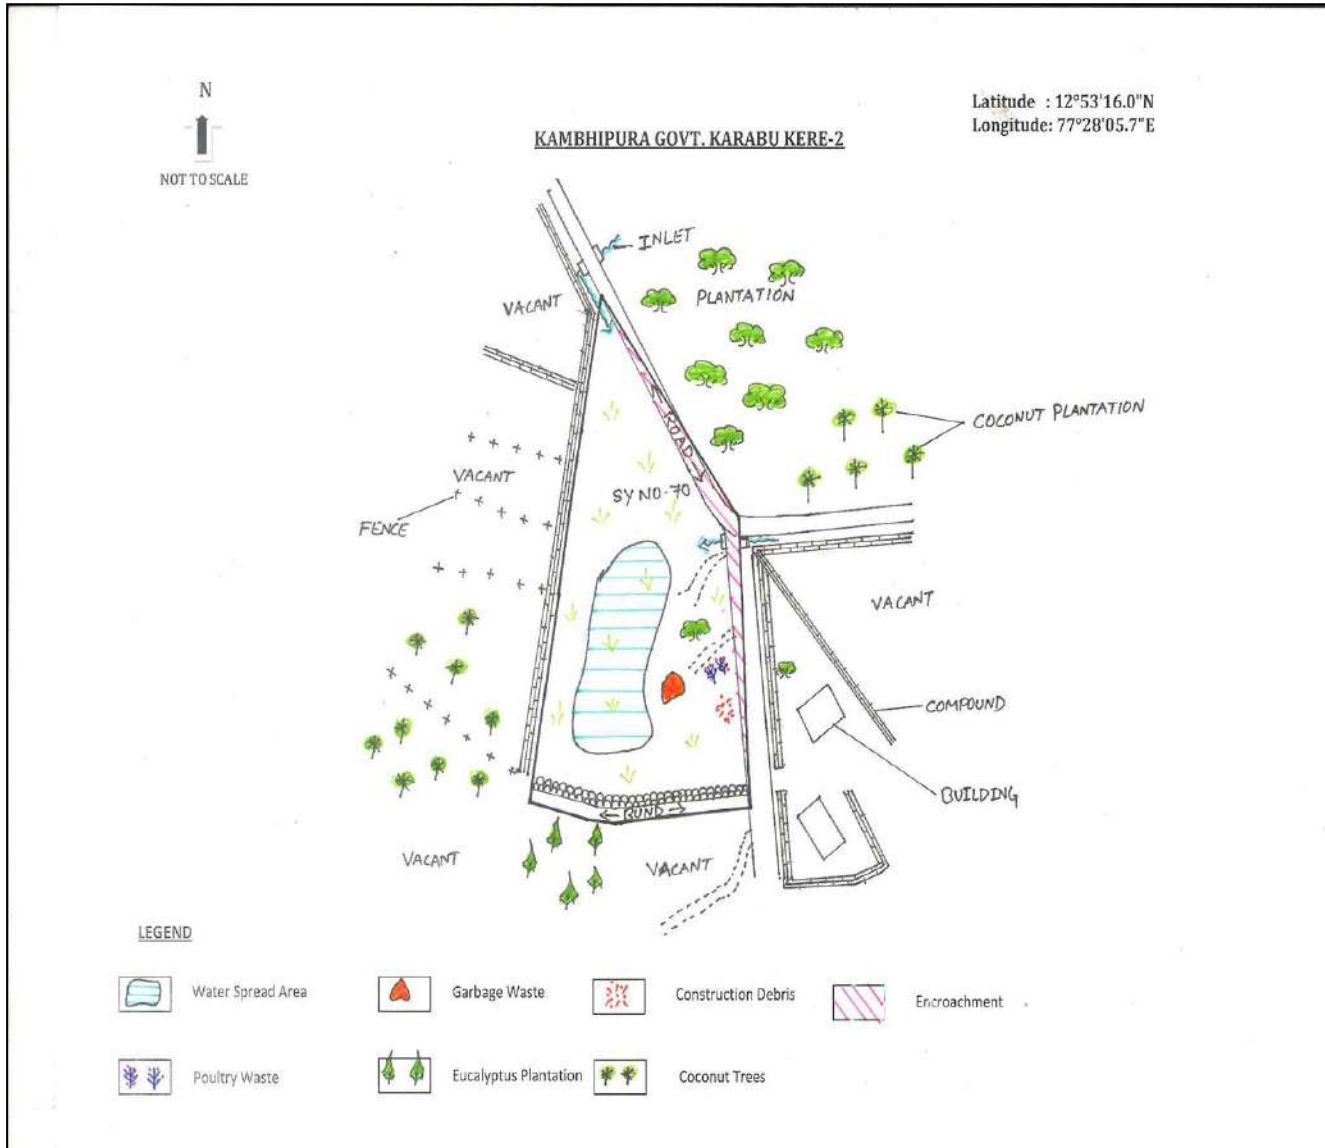
- Lake Cartography is for visual purpose only, which describes the features at the time of visit and not to scale.
- Encroachment of lake is only indicative. It needs to be verified with Department of Survey Settlement and Land Records (SSLR), Government of Karnataka.
- This is put out for general information of public at large, so the information is not usable to determine any boundary. Accordingly, the map information is indicative & user shall oneself verify as per prescribed legal procedure the actual boundaries of the survey number. No claim based on this information shall be entertained by the Government or any of its Departments.
- This information is for indicative purpose and is not usable for any legal purposes. Any use by anyone shall be at their own risk and cost.

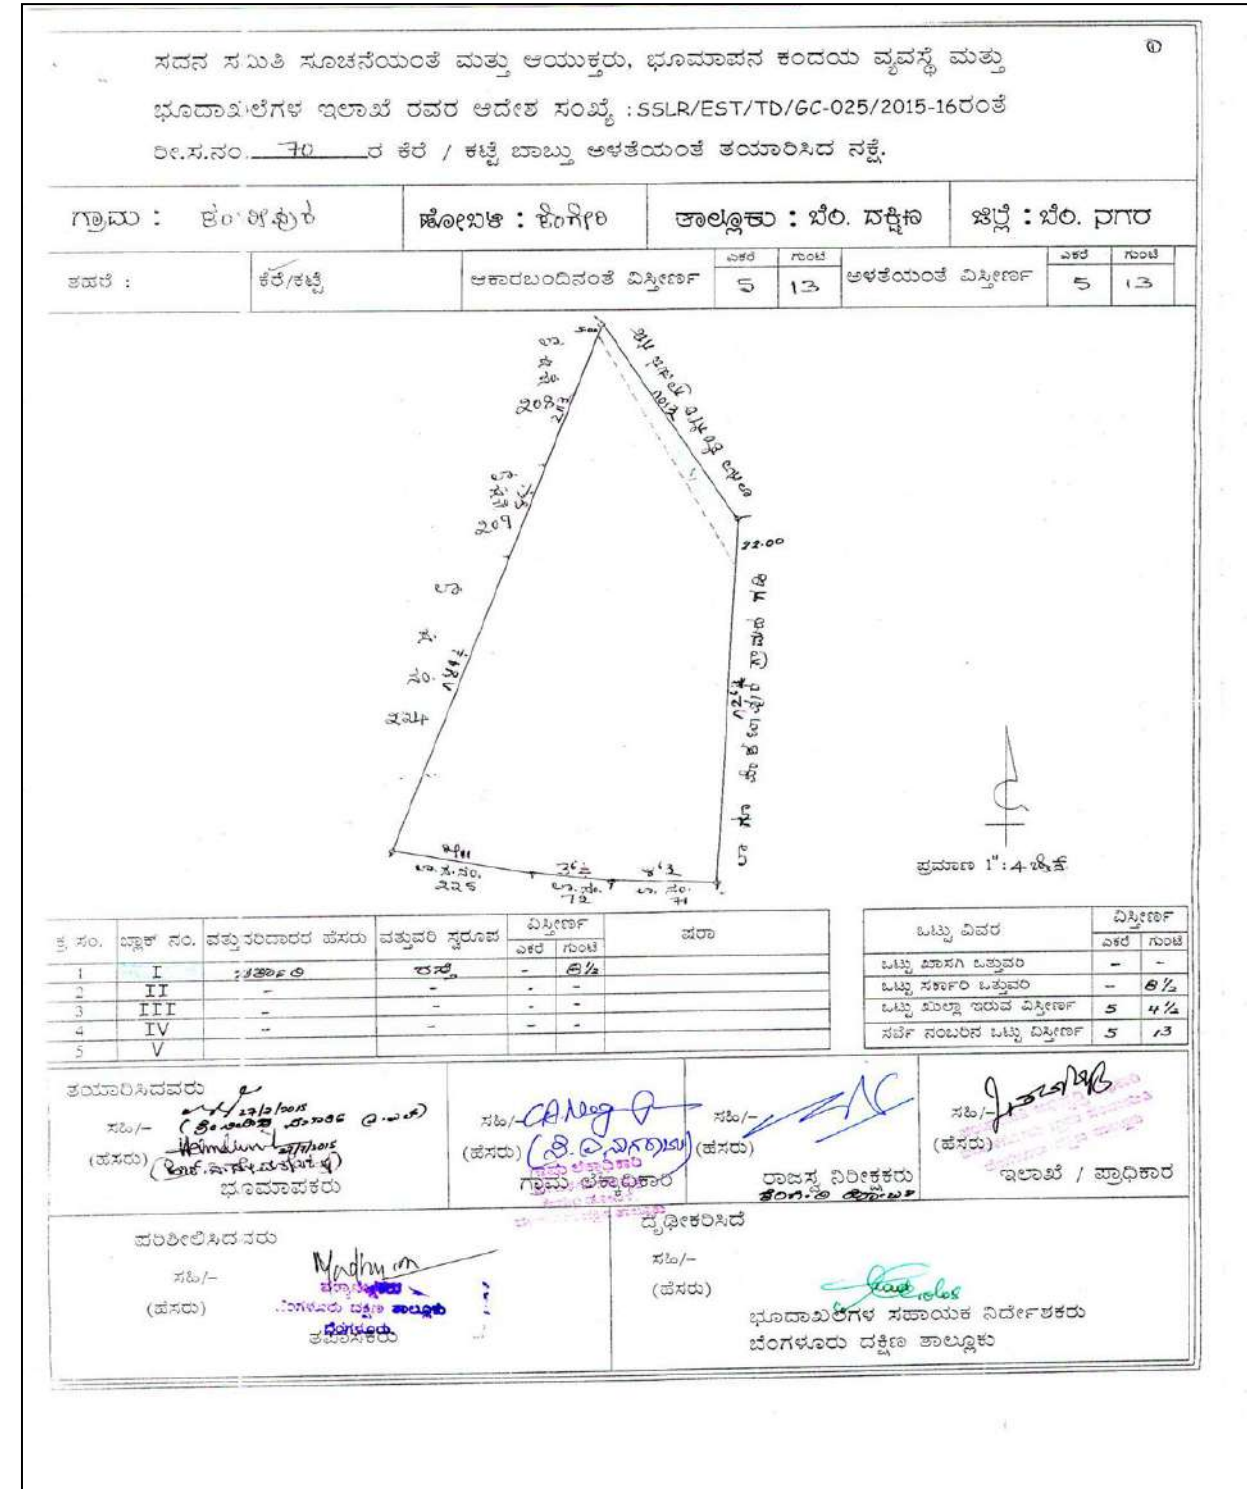
SSLR Surveyed Map for Kambhipura Govt. Karabu Kere-2

SSLR surveyed lake map was downloaded from <http://landrecords.karnataka.gov.in/revenuemaps/lakesurvey.aspx>
