Lake Name: Begur Lake1

Date of Visit: 01.02.2016

BASIC INFORMATION				
Other Name : Nil		EMPRI Code : BUBSBGbg_u_kr3-1406		Maximum Depth (m): 4
District Name : Bengaluru Urban		MI Tank Reg. No.: Nil		
Taluk Name : Bengaluru South		Year of Creation: ≈ 1966		Geographical Coordinates
Hobli Name : Begur		Year of Rejuvenation : Nil		Lat. 12°52'43.8" N
Village Name	Survey No.	Extent Area (A-G)	Source	Long. 77°37'58.2" E
Begur	94	137.24	RTC	Preservation Authority
Total Extent (A-G)		137.24	-	BBMP
MORPHOLOGY	WATER QUALITY		HYDROLOGY	
Elevation(m) : 902	Temperature (°C)	21.8		Status : Clean water
Inlet Drain : 2	pH	7.6		Type : Seasonal
Waste weir : 1	Conductivity (µS/cm)	754		Source of water : Rain
Sluice gate : 1	Light Transparency (m)	25		Upstream water body : Begur Lake2
Fence : Mesh & Wall	TSS(mg/l)	116		Downstream water body : Chikkabegur Kere
	TDS (mg/l)	600		
	Turbidity (NTU)	6		
Culverts : Nil	DO (mg/l)	5		Nature of Catchment : Urban
Check dam : Nil	BOD (mg/l)	16

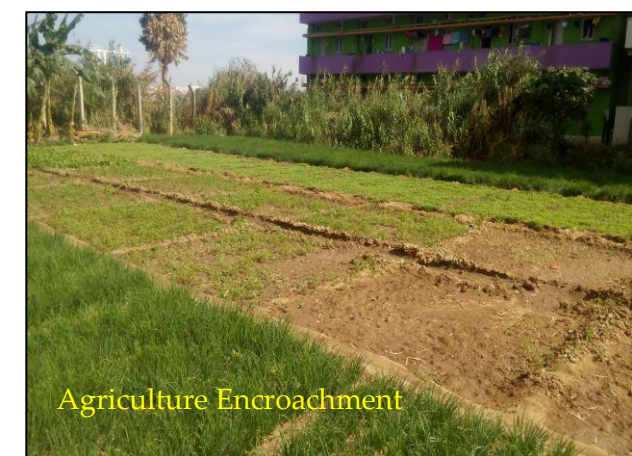
Agriculture Encroachment

S. No.	Issues	Strategies
1	Construction debris	Fence the lake and create awareness
2	Encroachment	Survey by the consent Authority & evict the encroachment

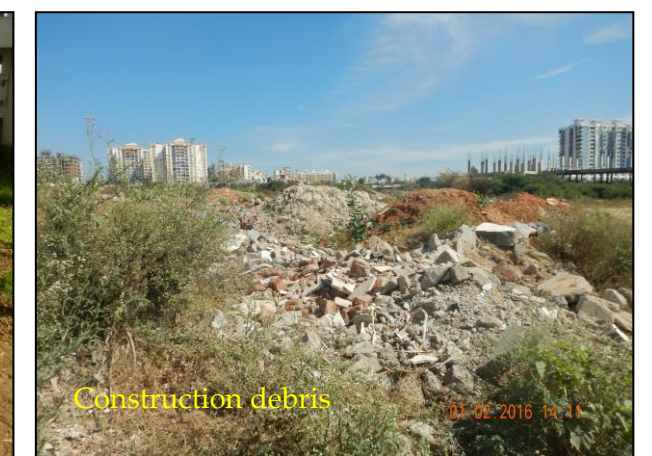
Construction debris
